Thumb Injury While Using Pneumatic Drill

Description of Incident (Occurred August 3, 2019)

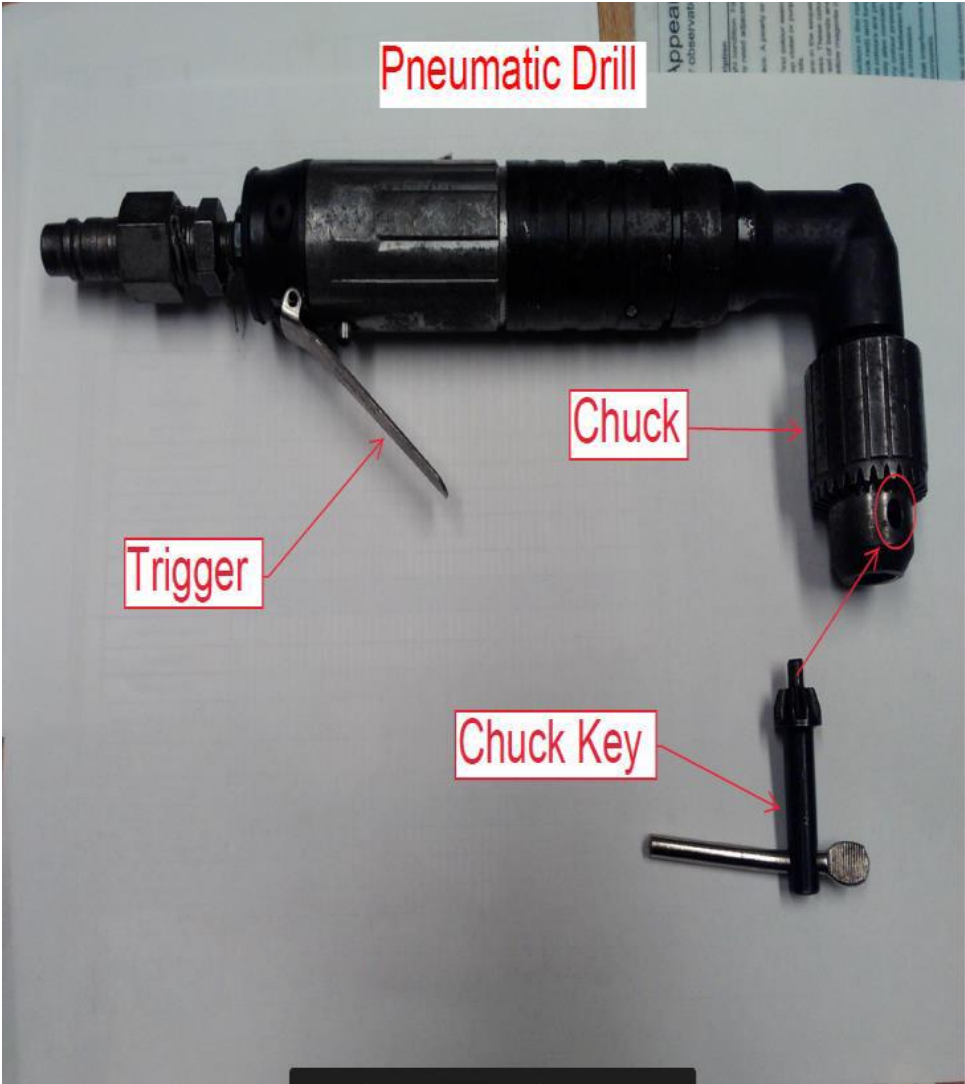
Picture 1- Overview of Pneumatic Drill

At approximately 5:00 p.m., a worker was tidying up on the Process Deck of an offshore production facility after completing the drilling of a hole on a Trunnion. When the worker attempted to remove the drill bit from a pneumatic drill using a chuck-key, the drill spun and bent his right thumb backwards. It was identified during the investigation that the air in the line of the drill was turned off, but the worker had failed to bleed off the air line to release potential stored energy, which caused the drill to spin. The Pneumatic Drill was not equipped with a trigger lock to prevent inadvertent activation. (Note: See attached images)

- The incident findings summary was shared with all workers, with an emphasis on the importance of identifying and mitigating all hazards, including specifically bleeding down air lines.
- A survey was completed and all pneumatic tools without locking triggers were removed from service.
- A policy was established to ensure that all pneumatic tools to be purchased in future require a safety lock to prevent inadvertent activation.

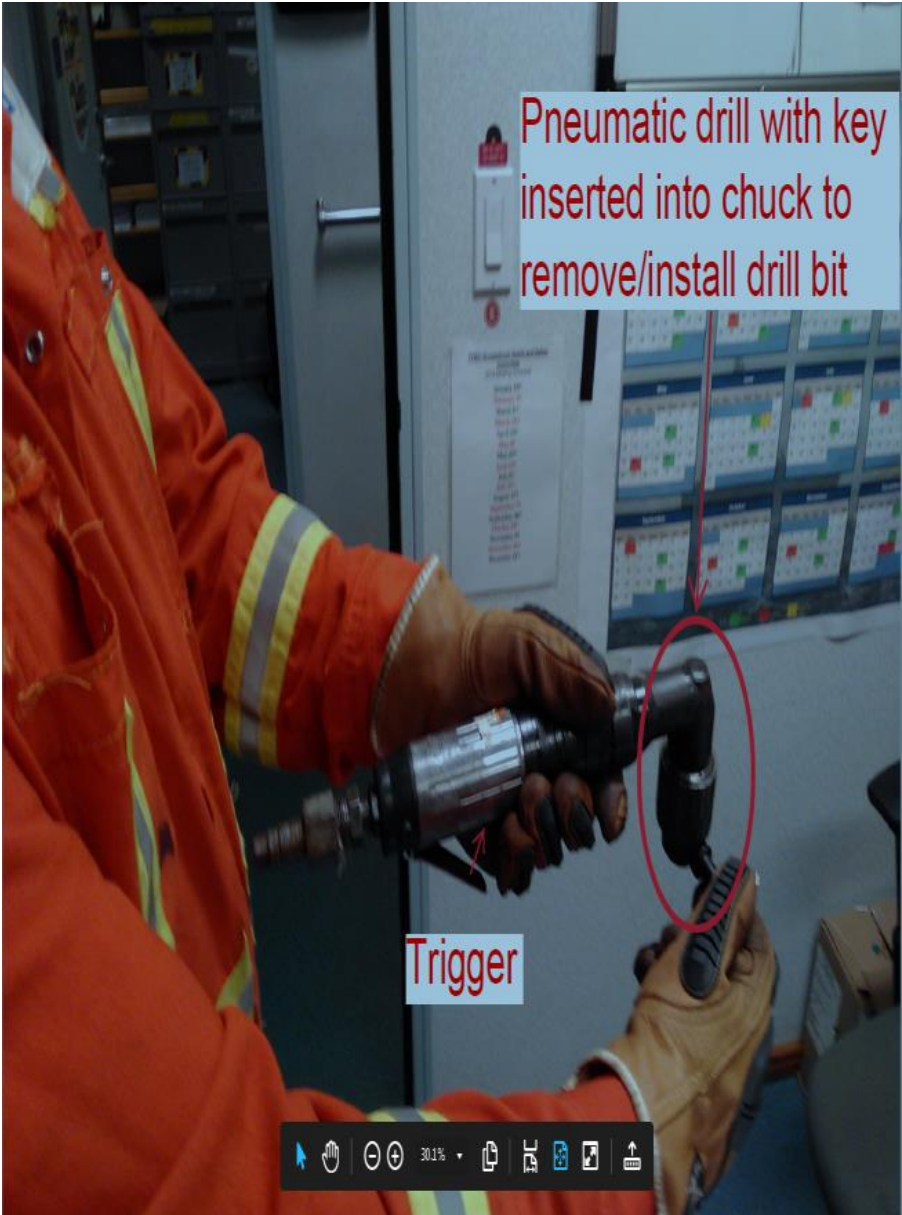
Picture 2 – Pneumatic drill with key inserted into chuck to remove/install drill bit
