## Diverter Valve Incident

### *Description of Incident (Occurred October 5<sup>th</sup>, 2022)*

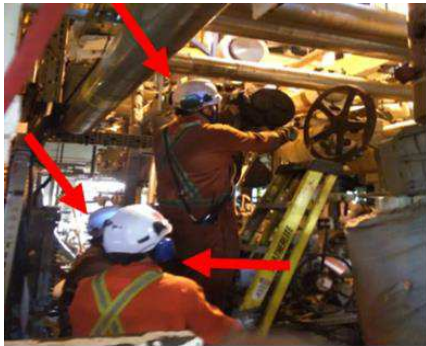
Re-enactment of personnel closing valve

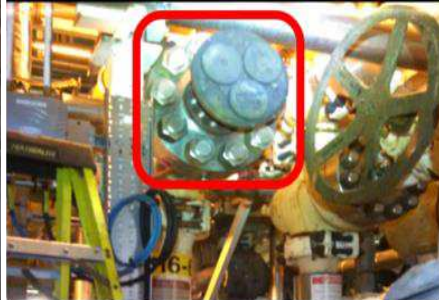
The root cause of the incident was an obstruction of the diverter valve vent, which failed to relieve the nitrogen gas that migrated past the valve packing from the body cavity into the bearing assembly (per valve design & API). As a result of the valve's vent being obstructed, the building of pressure was not detectable by the operator(s). The pressure required to fail gearbox cover bolts is 2-3MPa; the gearbox was not designed to retain pressure. See attached photos.

Upper diverter valve following event

- Add secondary and verifiable over pressure protection to gearbox assembly of like valves
- Share findings and risk potential; limit future purchase of this style of valve
- Complete post start up Forward Looking Infrared (FLIR) checks of diverter valves and add to regular FLIR preventative maintenance
- Complete equipment strategy review for similar single point of failure manual valves
- Develop operations specific leak testing document

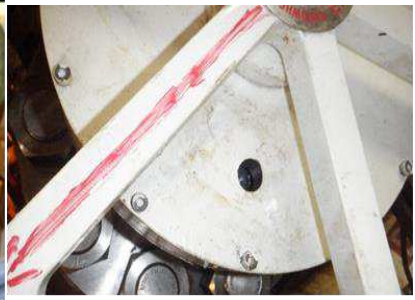
Secondary Vent; dust cap to be installed

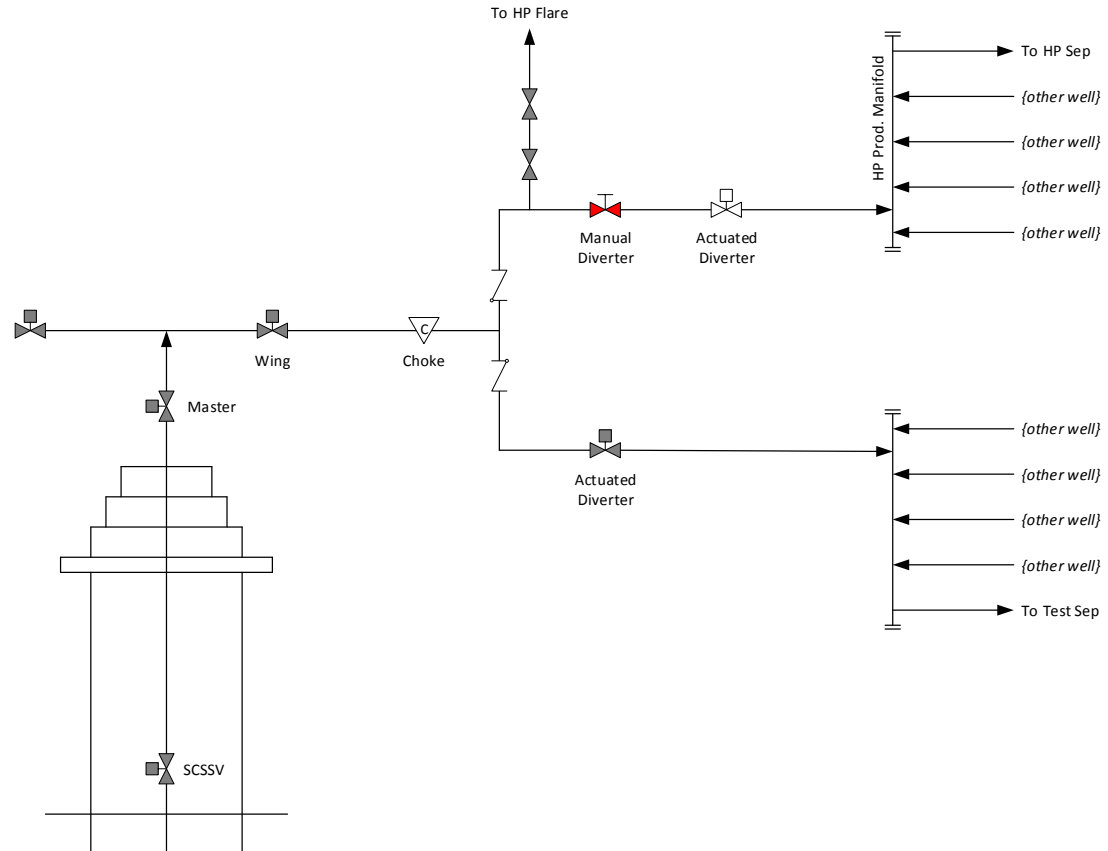
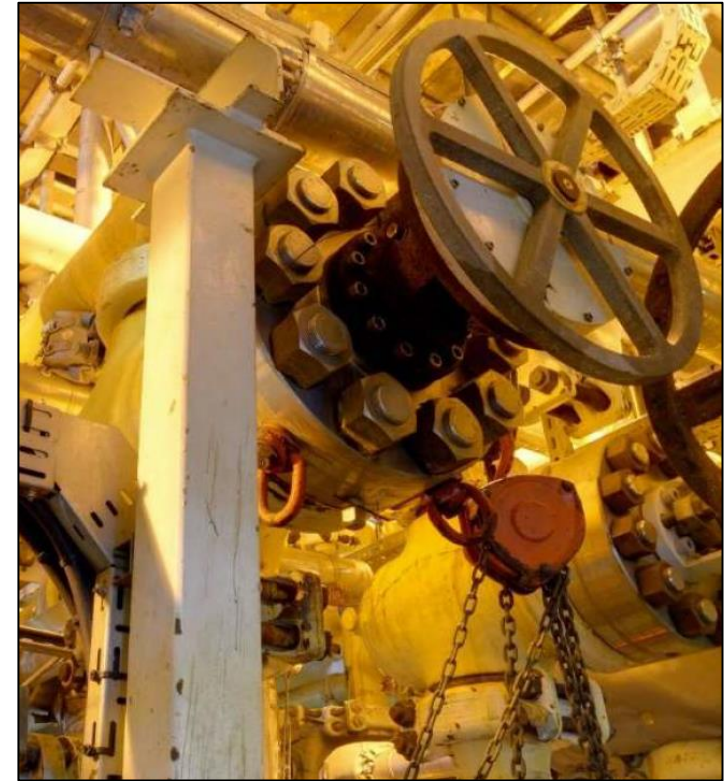
## Valve purpose and location

- Valve in question is upstream diverter valve for flowline to HP production manifold
- Valve is upstream of motor-operated diverter valve and provides double-block isolation for flowline

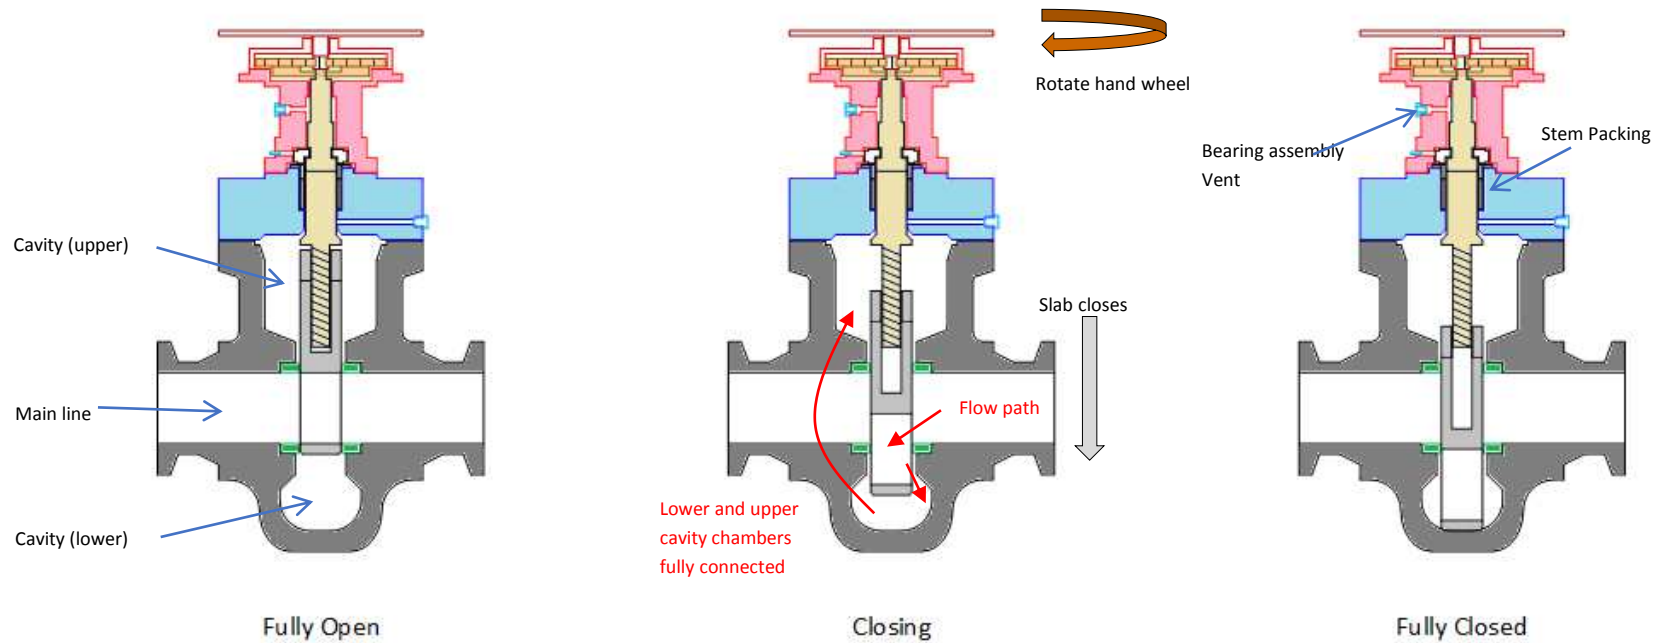
## Valve functioning and exposure to pressure

When valve is fully open, cavity is isolated from main line  
→ Possible leakage to cavity past Slab seals

When valve is in partially-open position, cavity is in full communication with main line

When valve is closed, cavity is once again isolated from main line

→ Valve is parallel style (not wedge), so primarily downstream sealing
