Dropped Object – Wood from Crane Boom Rest Pedestal

Description of Incident (Occurred November 23, 2022)

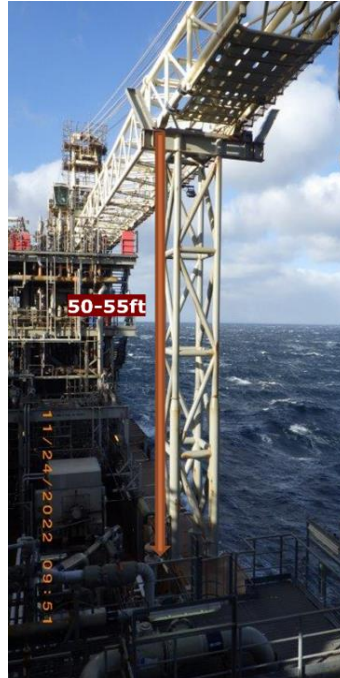
Through preliminary investigation, it was determined that the wood was released from a section of the crane boom rest cradle which resulted in the debris dropping approximately 50–55 feet to the deck below. The largest piece of wood located on the deck weighed approximately 1.3 lbs. The DROPS Calculator indicated that the potential of this dropped object was Major which could result in a Lost Time Incident (LTI).

Image description: Distance of drop from crane

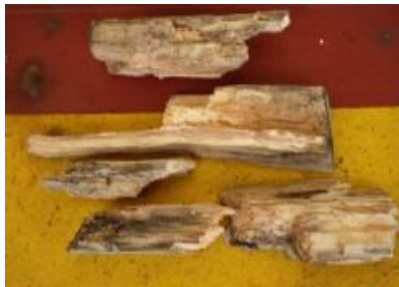
The investigation determined that the condition of the wood on the crane rest was previously identified as requiring replacement, however, was not prioritized based on the risk of a potential dropped object. Given the size of the material and the drop zone, coupled with the lack of secondary and safety retention, the crane boom rest should have been given a higher risk ranking.

The material used as lining (wood) for the crane boom rest is susceptible to the environment (i.e., moisture ingress) and therefore more prone to rotting. In addition, the crane boom can move slightly in the boom rest resulting in rubbing and friction that can cause damage to the wood lining.

Image description: Debris

- Replace current wood lining material with new or with an alternative material that is more resistant to the stresses and environmental influences. Fit new with primary fixing, secondary retention, and safety securing.
- Update Maintenance Based Risk Assessment processes to include use of Dropped Object Prevention Standard, DROPS Online Calculator and other industry learnings from similar Drops incidents. This will aid in proper risk ranking of Work Orders when associated with equipment at heights.
- Equipment at heights which have a drops potential should be identified and considered for inspection frequency, types of materials and possible methods of secondary retention and safety securing.
