Dropped Object During Hydraulic Jack and Pin Puller Operations

Description of Incident (May 28th, 2023)

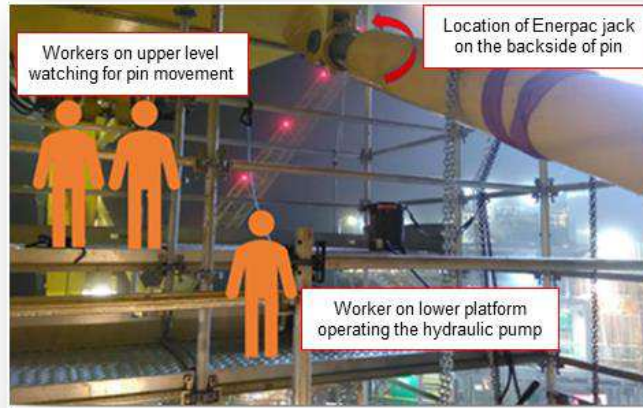
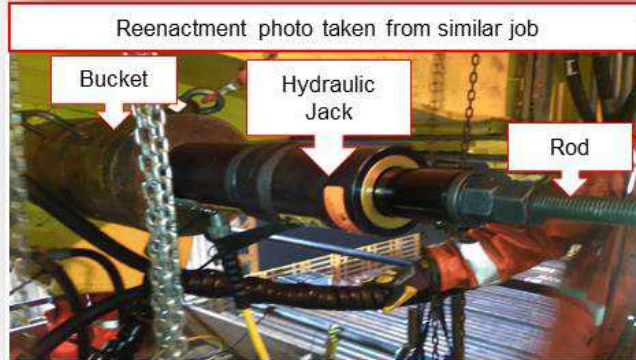
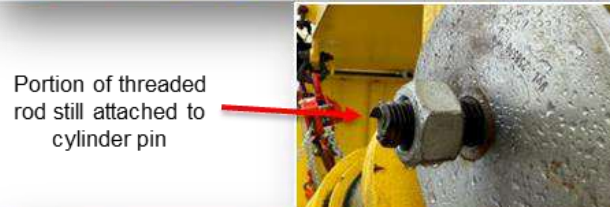
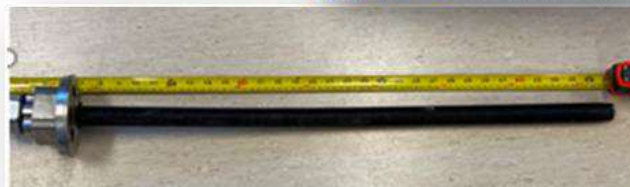
Related Images

The Drilling Maintenance Team on an offshore production facility were using a hydraulic jack and pin puller arrangement to remove the pins securing the luffing cylinder as part of planned maintenance on the Knuckle Boom Crane. Following four failed attempts with a 30-ton and 60-ton jack at max pressure, a larger 100-ton jack was utilized at half max pressure. On the fifth attempt the threaded rod connecting the jack to the pin failed, ejecting a 3 foot / 15 pound portion which travelled approximately 19 meters across the deck before deflecting off structural elements and coming to rest in a walkway approximately 26 meters below the Knuckle Boom Crane ejection point. See related images on page three.

- The Subcontractor-provided threaded rod and 60-ton jack was sent to the platform for this work activity.
- Both the 60-ton & 100-ton jacks were capable of exerting force in excess of threaded rod yield strength.
- Contractor procedure being utilized did not specify the hydraulic jack to be used, the load rating of the provided rod, or sufficiently describe steps to take if pin removal efforts were unsuccessful.
- The threaded rod was exposed to tensile loads above its yield rating during each of the three 60-ton pulls.
- The job safety analysis did not identify threaded rod parting as a potential hazard; the ejected rod travelled beyond red zones established to manage dropped object risk.

- Post-incident lab analysis confirms the threaded rod failed due to exposure to force greater than yield strength.
- The crew was not aware of yield load rating for threaded rod or recommended operating limits for the hydraulic jacks.

- Revise procedure to include (1) specifics including load rating and safe operating pressures specific to threaded rod and hydraulic jack being utilized, and (2) what to do if safe pin removal efforts are unsuccessful
- Ensure pin-pulling equipment is independently verified as fit for use prior to mobilizing
- Update job safety analysis to include threaded rod failure/ejection as potential hazard
- Consider alternative equipment designs to reduce risk of threaded rod failure
