Emergency Shutdown due to Gas Detection

Description of Incident (October 27, 2024)

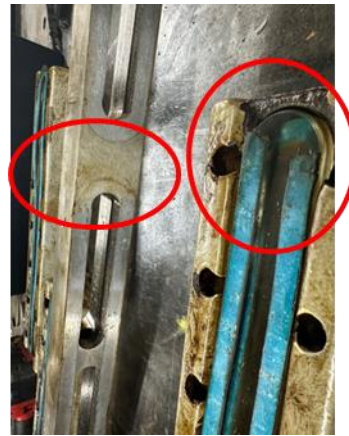
An offshore production facility went into alarm status, including a platform Emergency Shut Down, due to gas detection on three detectors in the process area. The investigation revealed a leak around the HP Separator sight glass. This resulted in active fire protection activation in the area (deluge release).

Figure 1: Leak Location

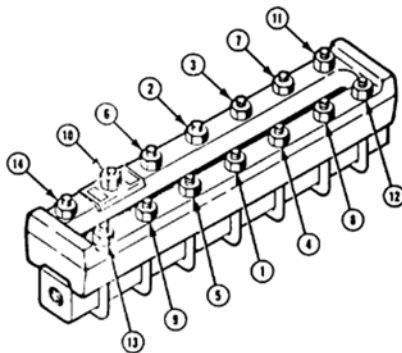
- The breaking torque of all bolts holding the glass to the body of the sight glass was found to be less than 20 ft. lbs. which is less than required. According to Original Equipment Manufacturer specifications, the torque valve should be 45-50 ft. lbs. This resulted in gas leaking between the house and the body.
- A gasket section was missing/damaged and there were signs of hydrocarbon release near the top section of the sight glass.
- The imprint of the gasket is visible on the main body, indicating that it was intact prior to release. This indicates that the gasket was not a contributing factor in the gas release. All other gaskets were in acceptable condition.
- The root cause was determined to be suspected thermal cycling over time, which led to bolts becoming loose, leading to release.

Figure 2: Failed Gasket

- Check and re-torque as required all similar sight glasses beginning with sight glasses in hydrocarbon service.
- Implement routine preventative maintenance for torque checks based on findings from initial re-torque.
