## Dropped Object: Failed Lifting Eye

### *Description of Incident (May 19, 2025)*

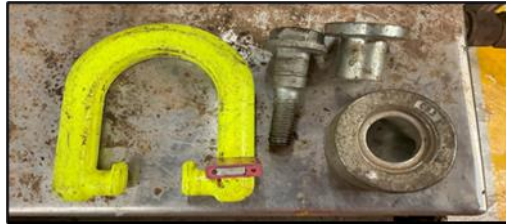
*Fig. 1. Disassembled lifting eye. Pieces from Left-Right: D-ring, bolt, washer, nut*

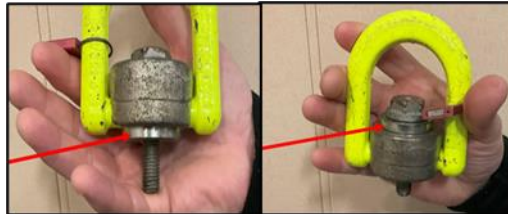
A post incident inspection of the motor and rigging gear found that the lifting eye had backed itself out of the threaded installation slot due to incorrect swivel eye assembly, reducing the length of usable threading. This occurred as the washer was incorrectly installed on the top of the nut instead of the bottom.

*Fig. 2. (L) Correctly assembled lifting eye; (R) Incorrectly assembled lifting eye*
