Electric Shock

Description of Incident (June 22, 2024)

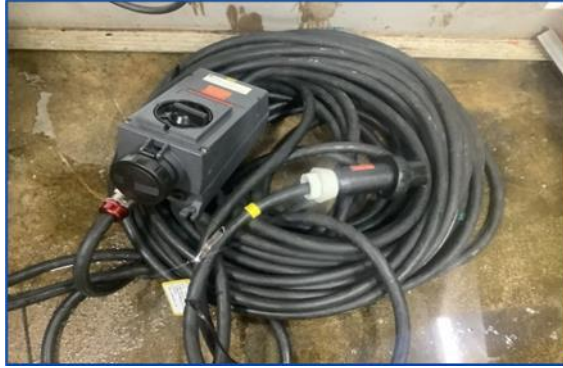
It was later determined that there was no fault in the heater, however the ground cable in the 600V temporary power cord had become disconnected, resulting in the electric shock. See related images attached.

Although all three phases of the temporary power cord showed continuity, the ground did not. Internal inspection revealed that the ground wire was disconnected from the pin lug. The detached ground conductor resulted in exposure to voltage from a single phase (approximately 347V). No discrepancies were found in the work management system review. While the inspection program for cords met requirements under the applicable code (CSA Z462) opportunity for improvement was found in the Assured Equipment Grounding Conductor Program to do proactive internal inspections.

Fig 1: Temporary Cable with disconnected ground (green)

- Cease all in-progress work utilizing temporary power cables until proper continuity is confirmed in all pins, inclusive of internal inspections.
- Update current temporary power cable inspection guidance to formally implement an Assured Equipment Grounding Conductor Program.
 - Written instructions will be clarified to clearly document internal inspection criteria and continuity and connection test criteria.
 - Temporary power cable inspection guidance will also be revised to ensure all inspections occur on the same frequency.
 - Above and beyond Assured Equipment Grounding Conductor Program guidance and continuing testing will be incorporated into pre-use inspection testing requirements.

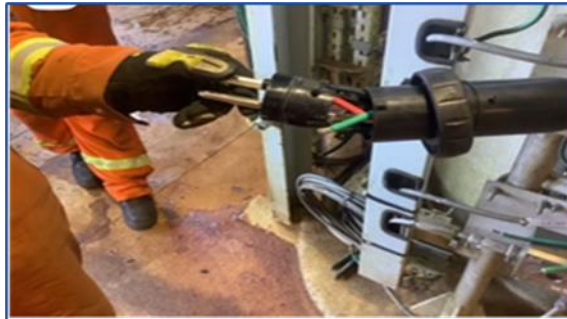
Fig 2: Loose Ground on Temp Power Cord (Internal Inspection)
