Near Miss – Light Post Installation

Description of Incident (June 11, 2025)

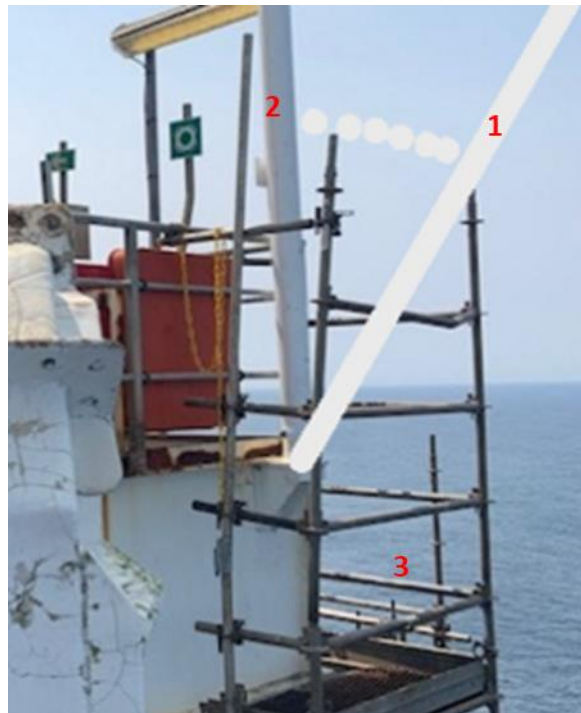
Fig. 1. Position of Light Pole and Scaffolding

A work crew were installing a light pole on the upper deck of an offshore platform. As the pole was being maneuvered to line up the bolt holes, both slings failed simultaneously causing the pole to shift, resulting in the pole resting against the upper rail of the scaffold in place for this job. Two workers held the tagline helping to stabilize the light pole on the impacted scaffold rail. One bolt had been installed and it helped keep the light pole base in position. Nobody was injured during the incident.

The crane overpulled on the wire rope slings used to lift and position the light pole resulting in both slings failing simultaneously. The selected rigging arrangement was certified and had sufficient capacity for lift. Using the pedestal crane to lift a light pole and maneuver it into place to bolt it to the platform structure, should have been recognized as a non-routine task. A lift plan checklist was not completed for this individual scope of installing the light pole.

- 1. Light Pole Leaning against scaffold when slings failed*
- 2. Light Pole in Final Installed Position*
- 3. Position of worker on scaffold platform*

- Communicate expectations of Rigging and Lifting Safe Work Practice all affected contractors involved in planning and developing work scopes onshore.
- Determine if enhancements are needed to engineering/construction contractors implementation process to improve identification of non-routine lifting activities, need for lifting eyes and/or lifting plans.
- Define parameters for use of permit for routine lifts then update documentation and communicate expectations.
