## Crane Operations Near Miss

### *Description of Incident (Occurred March 20, 2022)*

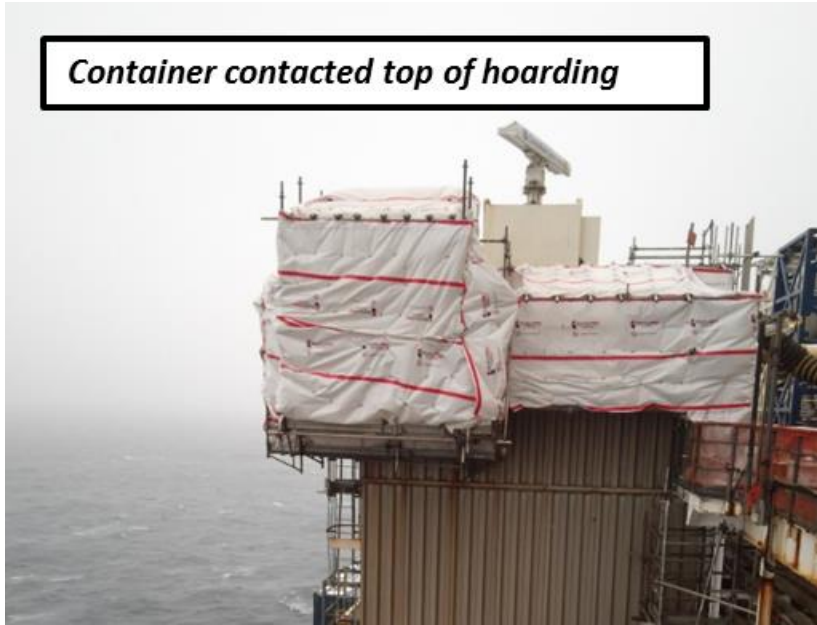
While lifting an empty mini container from one laydown area to another on an offshore production facility, the container made contact with a hoarding that was occupied by three workers completing coatings activities. There were no injuries to personnel as a result of this incident. *Note: See attached photos*

The investigation into the incident revealed that the crane operator changed lift paths without communication to the lift team or without conducting a last minute risk analysis (LMRA). It was also noted that painting activities undertaken in the hoarding during this incident were not flagged as a key activity for simultaneous operations considerations during the daily work coordination meeting. Other key factors identified as contributing to the incident included the fact that the hoarding was installed and previously inactive for an extend period of time, that simultaneous operations considerations between the lift team and painters was not covered in Permit to Work, Job Safety Analysis or Tool Box Talks, and there was no formal guidance within lifting procedures for lifting over hoardings.

*Container contacted top of hoarding*

- Field actions:
  - Use LMRAs before work execution and when conditions change.
  - Pre-job planning must consider all activity and simultaneous operations considerations within the work area.
  - Workers should speak up if they observe error prone situations, or lack of clarity and guidance.
